Debris/Ice/TPS Assessment And Photographic Analysis For Shuttle Mission STS-31R

June 1990

Charles G. Stevenson
NASA/Kennedy Space Center

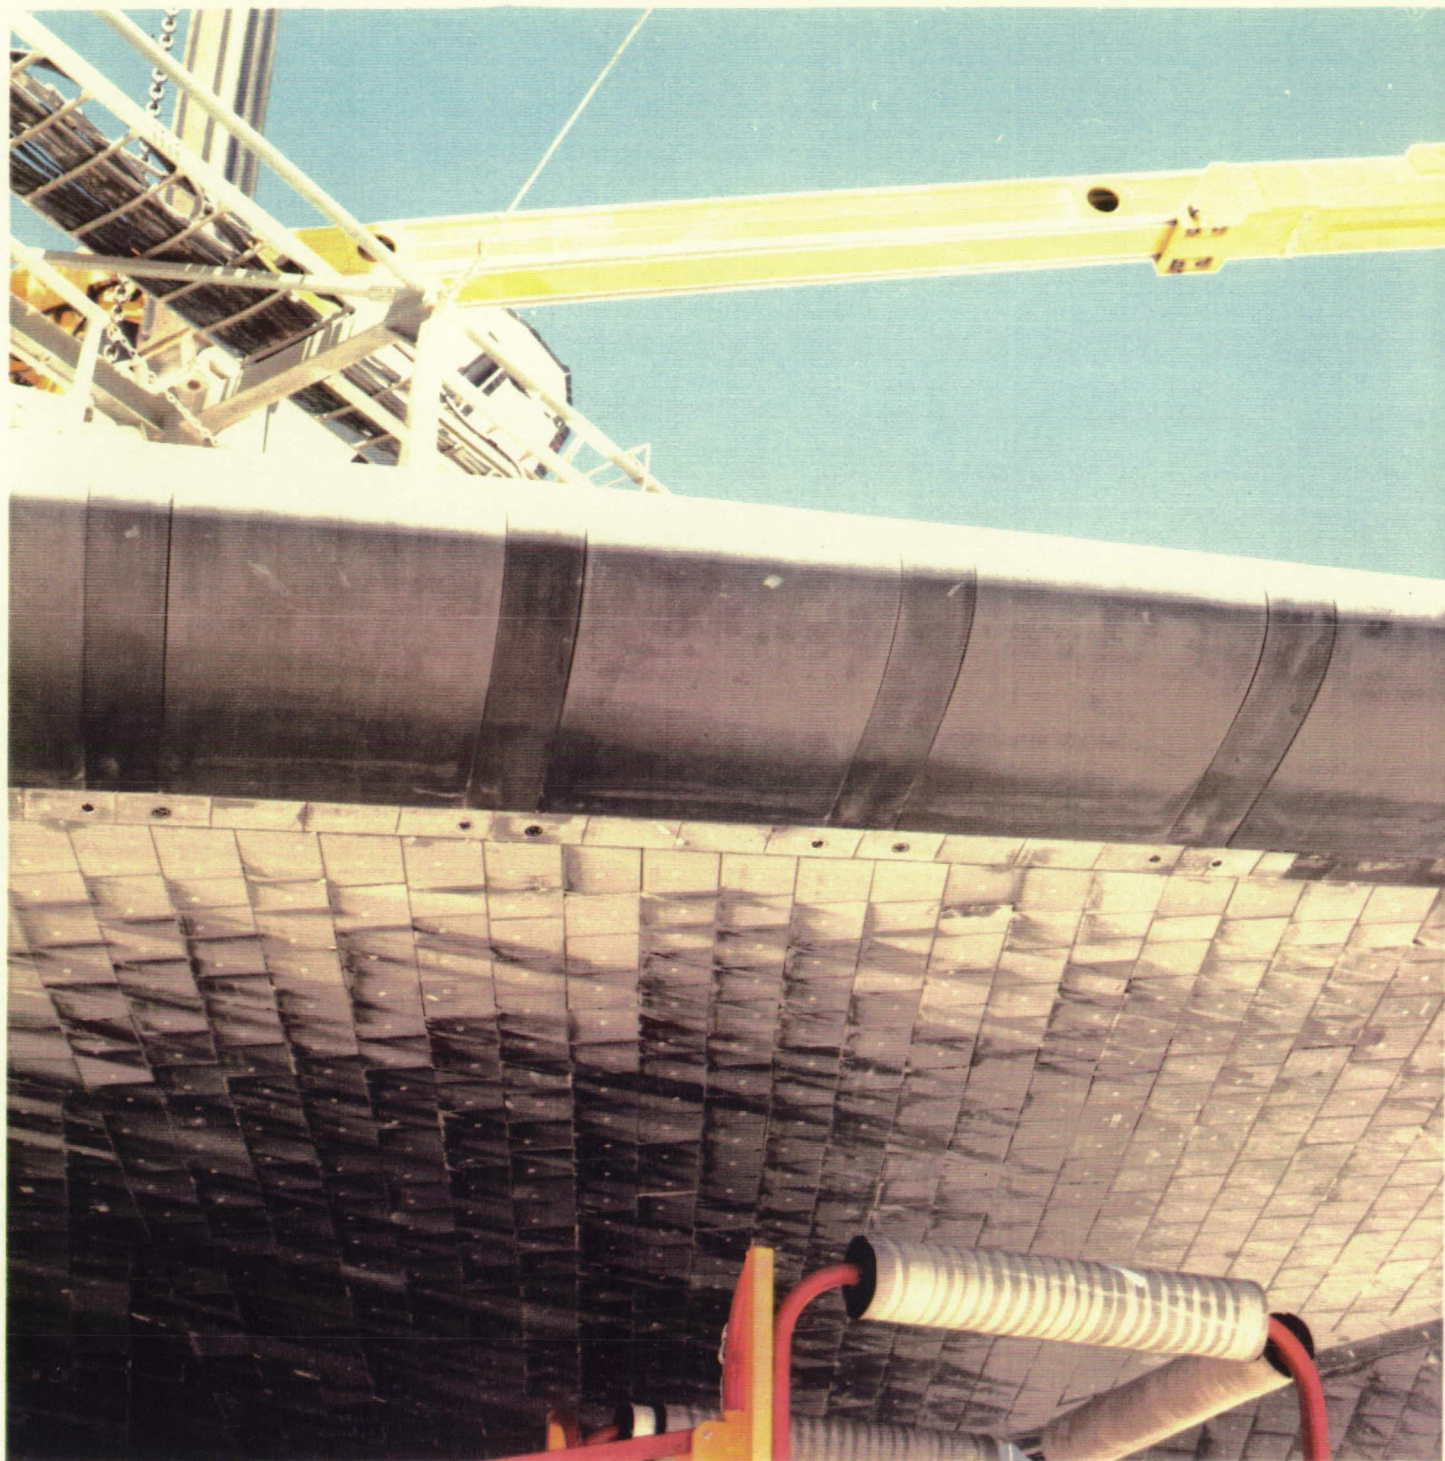
White residue on wing leading edge RCC panels was paint, TPS materials, BSM exhaust residue, and landing site products

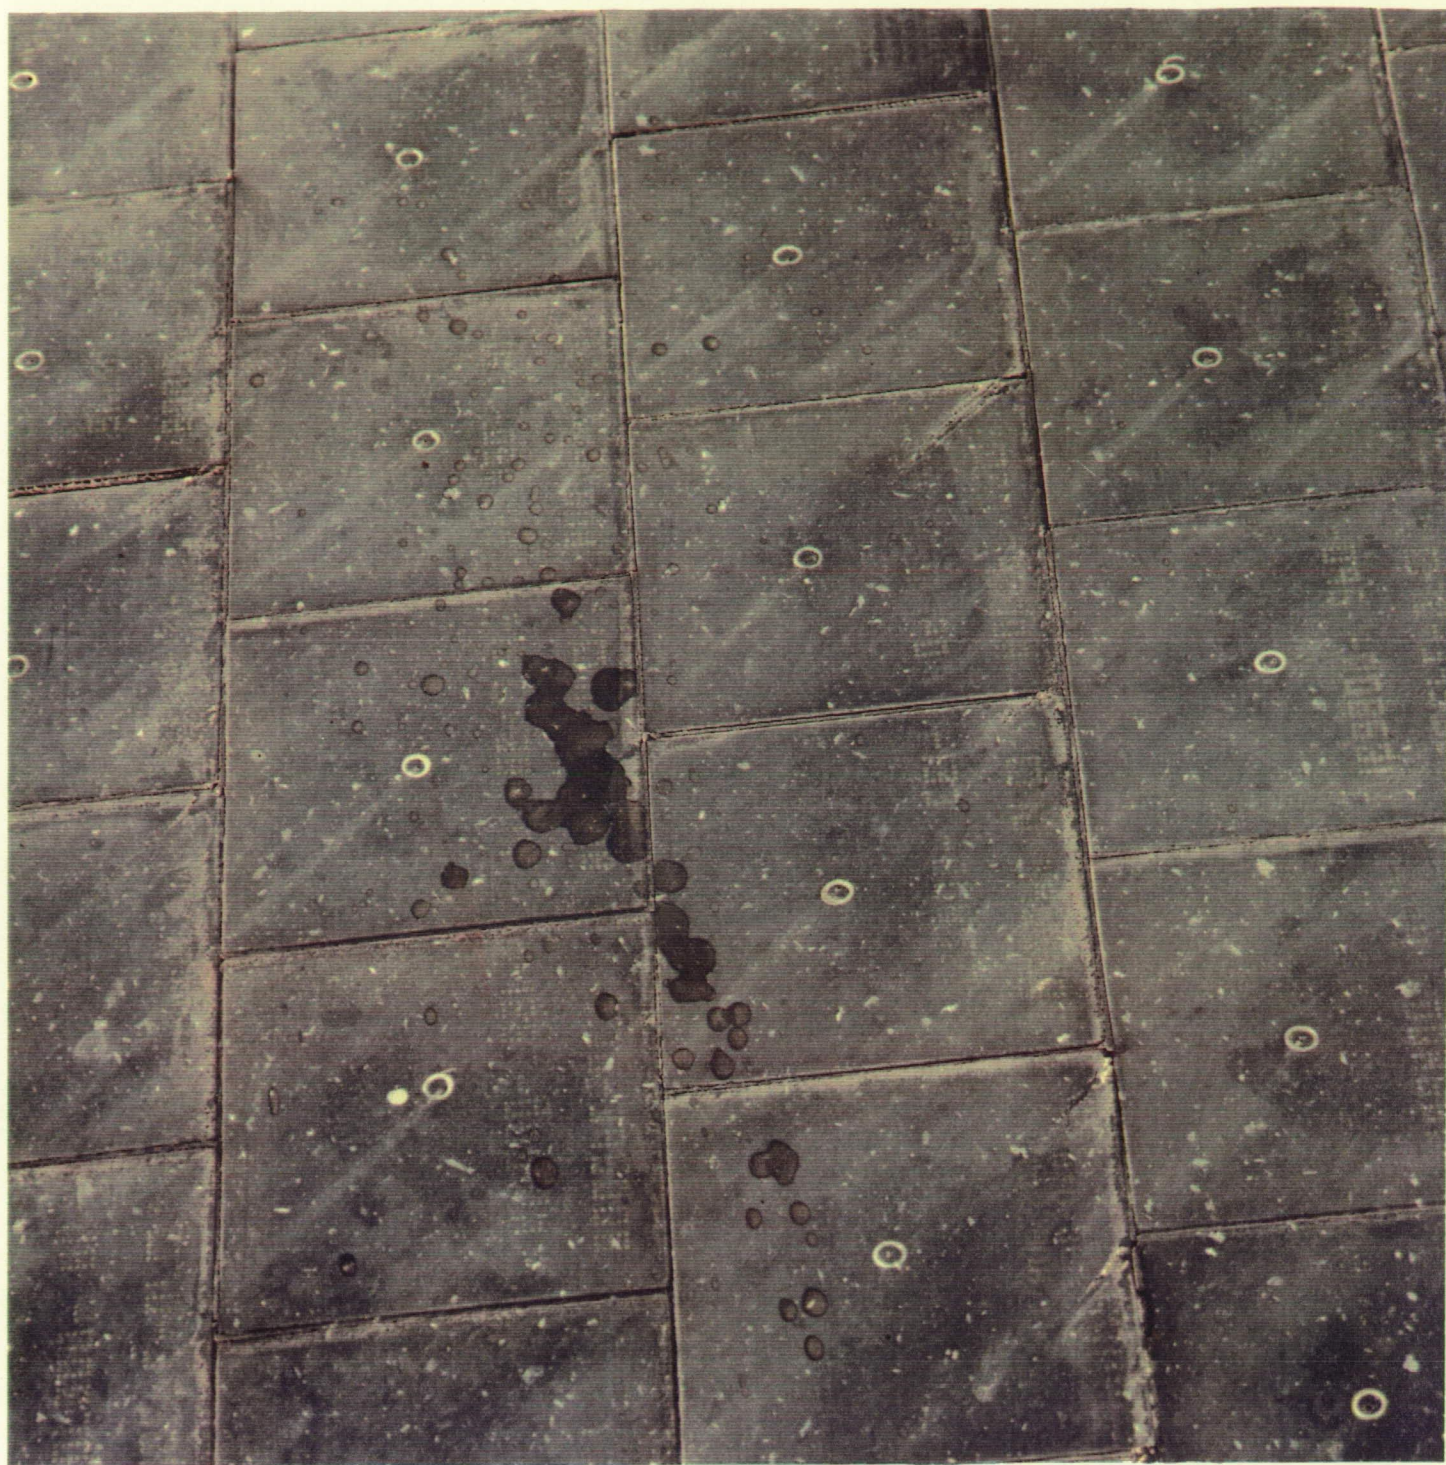
Analysis of brown residue on lower surface tiles aft of RH MLG
revealed paint, TPS materials, and landing site products
